Contract #: 04-0120F4Cty: SF/ALA Rte: 80 PM: 13.2/13.9File #: 69.28**WELDING INSPECTION REPORT****Resident Engineer:**Siegenthaler, Peter**Address:** 333 Burma Road**City:** Oakland, CA 94607**Report No:** WIR-024111**Date Inspected:** 01-Jun-2011**Project Name:** SAS Superstructure**OSM Arrival Time:** 1900**Prime Contractor:** American Bridge/Fluor Enterprises, a JV**OSM Departure Time:** 700**Contractor:** Zhenhua Port Machinery Company, Ltd (ZPMC), Changxing Island **Location:** Shanghai, China**CWI Name:** See Below**CWI Present:** Yes No**Inspected CWI report:** Yes No N/A**Rod Oven in Use:** Yes No N/A**Electrode to specification:** Yes No N/A**Weld Procedures Followed:** Yes No N/A**Qualified Welders:** Yes No N/A**Verified Joint Fit-up:** Yes No N/A**Approved Drawings:** Yes No N/A**Approved WPS:** Yes No N/A**Delayed / Cancelled:** Yes No N/A**Bridge No:** 34-0006**Component:** OBG**Summary of Items Observed:**

**OBG Trial Assembly**

Visual Inspections of segment 13AE PP119 +1500mm to PP120 upper surfaces on the CB side:

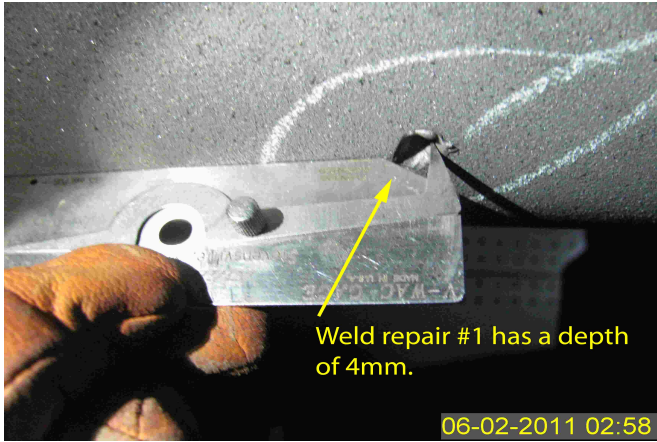
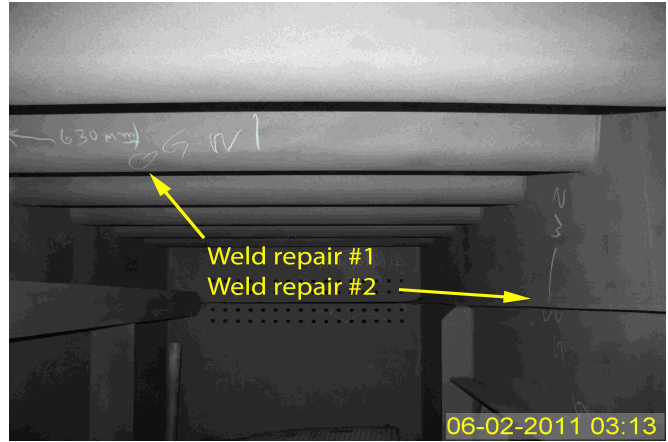
ZPMC requested Caltrans personnel to perform visual inspections of OBG segment 13AE between PP119+1500 to PP120 cross beam upper section on June 2, 2011 at around 02:40 hours following the initial pre-blast cleaning of the steel surfaces. This QA Inspector along with other QA Inspectors performed random visual inspections of these areas and observed the following items appear to require weld repairs. This QA Inspector observed item #1 as listed below and the other areas were identified by other QA Inspectors. The following areas were marked on applicable drawings which were forwarded to dayshift QA Inspectors for tracking of repairs.

1. Arc gouge near the bottom of a closed rib on deck plate DP3075A closest to weld 140. This gouge is located approximately 630 mm from SEG3013B @ PP120.0. Depth of the gouge is approximately 4.0 mm.
2. Slag inclusion approximately 14 mm long, 1.5 mm deep located 3050 mm from the end of the weld closest to the center of the OBG. The slag line is in the face of weld SEG3007D-226 on the PP120 side of the weld.
3. Overlap and incomplete fusion in weld relief hole, Longitudinal Diaphragm to deck plate weld @ PP119+1500.
